FIRE - PREVENTION REPORT

**HIGHWAY DEPARTMENT
STATE OF NEW JERSEY**

**W. S. BORDEN CO., AGENTS
TRENTON, NEW JERSEY**

GENERAL COMMENTS
Fernwood Station, Trenton, N. J.

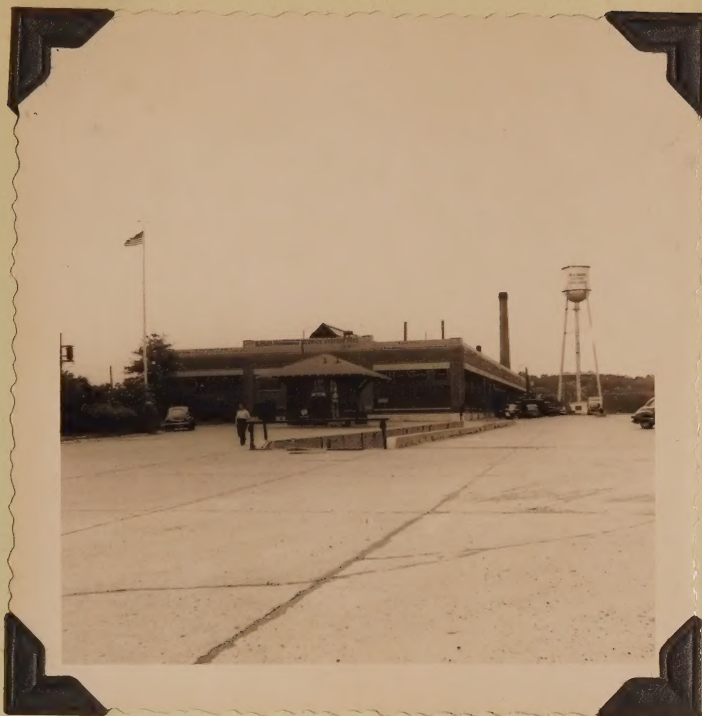
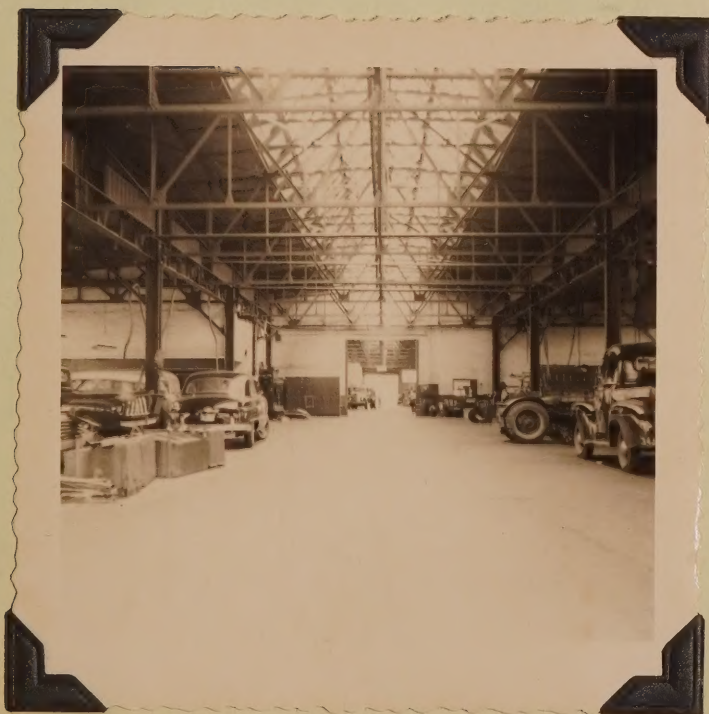
Main Garage Building #1 and 1A

<u>Construction</u>	A large one high story, brick building with slag-covered plank on exposed steel truss roof. Wood block on concrete floor. Large area steel sash windows. Brick-parapetted division wall with opening protected by automatic-closing fire door.																				
<u>Mechanicals</u>	Modern heating, lighting and plumbing systems. Automatic sprinkler system.																				
<u>Occupancy</u>	General repair work on trucks and appurtenant highway maintenance equipment. Machine shop, welding, forging, woodworking, paint spraying, etc. Offices, stock room, boiler room, etc.																				
<u>Fire Extinguishers</u>	Eight 2½-gallon foam, three 1-qt. C.T.C. and two 5-gallon C.T.C. on wheels. Numerous sand pails. Standpipe and hose system.																				
<u>Values</u> (as of 1/1/49)

Provide metal covers for all metal trash barrels.

Provide Underwriters' Laboratories, Inc. labeled, oily waste safety cans for machine shop and repair shop.

Re-hang the 2½-gallon foam extinguishers so that the tops of same are not over 5 feet above the floor and remove obstructions to easy access to them.

Keep combustible materials away from forges.

Provide separate, well-detached, fire-resistive building for paint spraying operations.

Use aerosene, carbon-tetrachloride or other less volatile solvent than gasoline for washing auto and truck parts.

Provide self-closing metal-clad door for boiler room.

Discontinue use of wood barrels for storage of sawdust and wood shavings.

Replace present unlined linen fire hose with new hose of same type.

Provide hose for C.T.C. extinguisher on wheels and keep same under constant pressure.

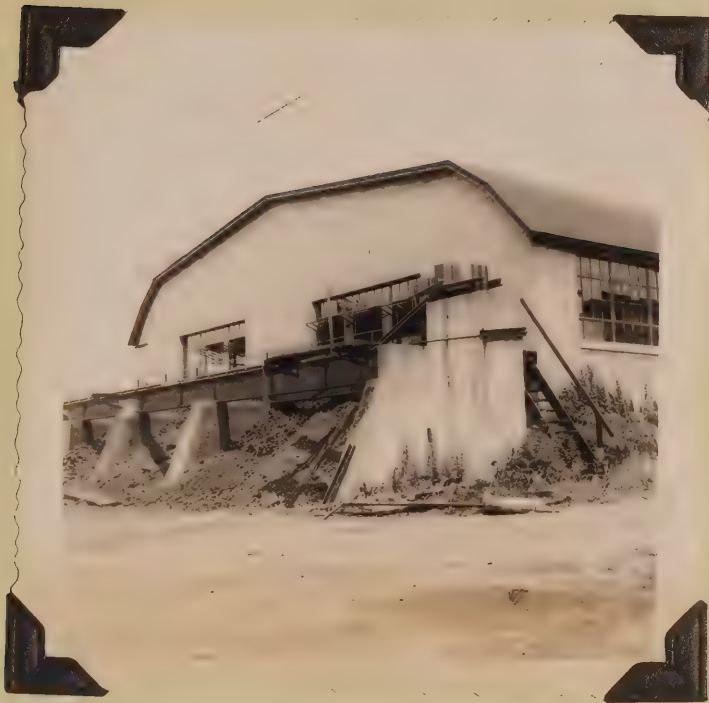
Rear View

<u>Fire</u>	One 2½-gallon pump tank. One sand
<u>Extinguishers</u>	pail.

Provide sheet metal or hard asbestos board protection for roof boards directly above line of boiler allowing 3-inch air space between baffle and roof boards.

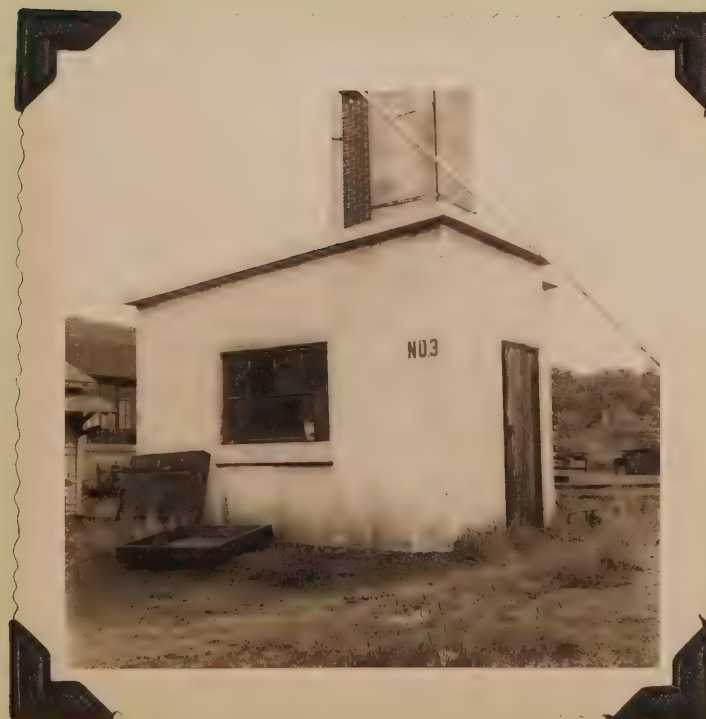
Pump House Building #3

<u>Water Supply Tank</u>	Cylindrical steel, 100,000 gallon tank on 100 foot steel tower. Top 30,000 gallons piped for domestic service. Balance reserved for yard hydrant and automatic sprinkler system.									
<u>Pump House</u>	One story, concrete roof, floor and walls. Located at base of water tank tower.									
<u>Mechanicals</u>	Small H.B. Smith boiler (coal-fired) for heating riser and tank water. Small coal-fired stove for heating pump house. Electric lights.									
<u>Values</u> (as of 1/1/49)

Building	-	\$5,500.	Contents	-	-	Total		\$5,500.
Building	-	\$5,500.								
Contents	-	-								
Total		\$5,500.								
<u>Suggestions</u>	<p>Provide additional support for 3-inch domestic water supply pipe to eliminate side-sway.</p> <p>Provide gauge to indicate level of water in tank.</p>

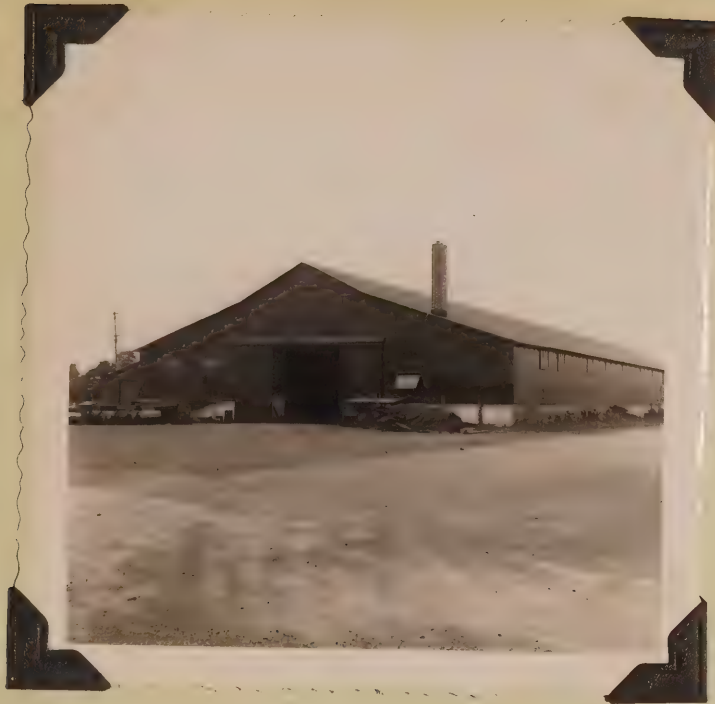
Storage Building 27

A large one story, frame building. Concrete floor and foundations. Metal sheathed walls. Composition-covered roofing on one-inch boards on 2" x 5" rafters on steel purlins. Steel columns. Stove heat (office only). Electric lights.

Storage of stocks of paints in cans, bags of nails, 5⁰ gallon drums of motor oil, gear grease, tire chains, boiler tubes, reinforcing rods, wire cable, automotive parts, supplies, etc.

In view of the high value of supplies stored in this building we suggest removal of same to a fire-resistive sprinklered building which it is suggested be provided for this purpose.

Refill water barrels where necessary.

Provide 12 inches of additional metal protection for wood floor at front and one side of coal stove located in office section.

Discard unapproved dry powder tube extinguishers.

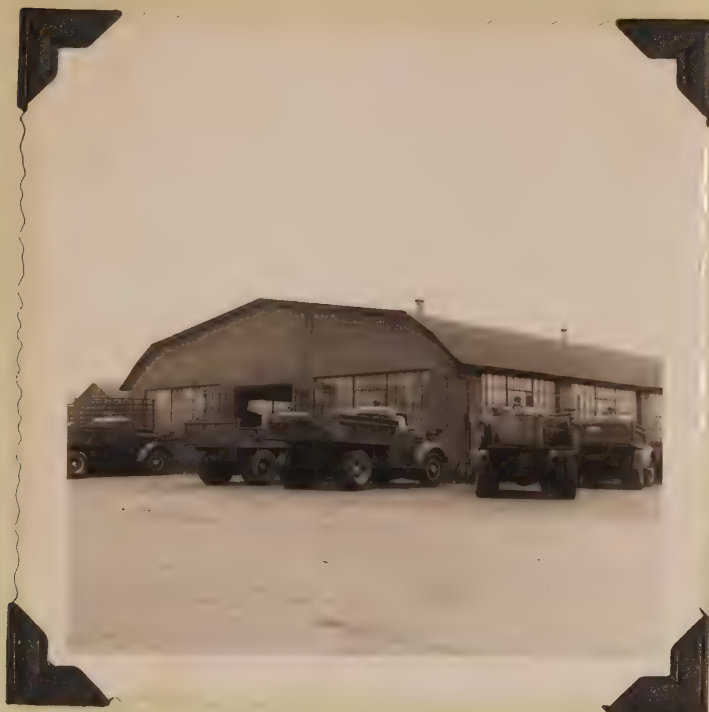
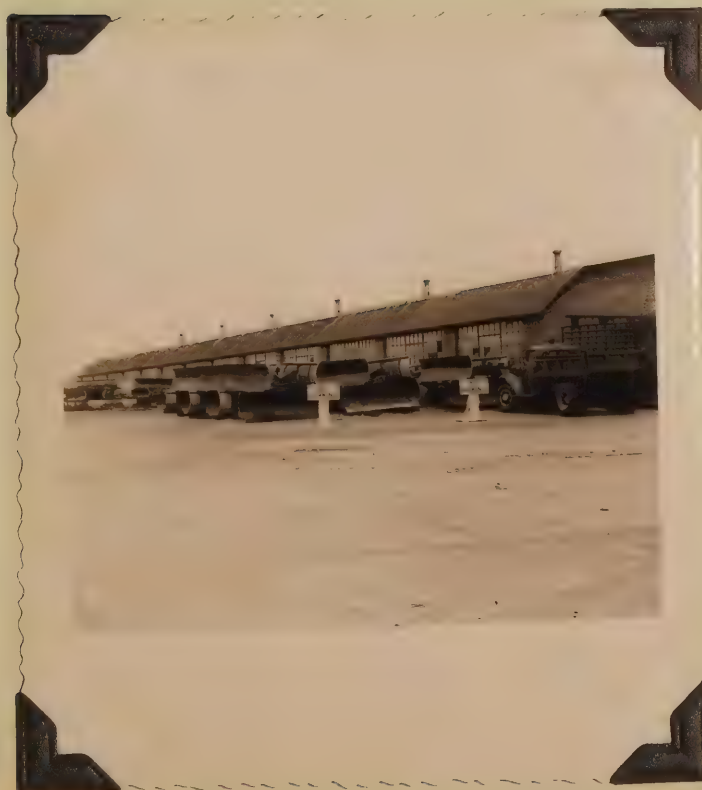
Equipment Storage Building #7

<u>Construction</u>	<u>Walls:</u> brick with brick pilasters. <u>Floor:</u> concrete. <u>Foundations:</u> concrete. <u>Roof:</u> composition covering on 2" plank on 3" x 12" purlins on steel truss. <u>Windows:</u> steel sash.
<u>Mechanicals:</u>	No heat. Electric lights, wiring in conduit.
<u>Occupancy</u>	Storage of trucks only.
<u>Fire Extinguishers</u>	One 2½-gallon anti-freeze, one 2½-gallon pump tank, seven 1-quart C.T.C. plus numerous sand pails.
<u>Values</u> (as of 1/1/49)	Building - \$18,750. Contents - - Total \$18,750.

We suggest a general clean-up of floor and removal
of loose papers.

Replace sand pails that have been damaged by being
bumped by trucks.

Discard unapproved dry powder tube extinguisher.

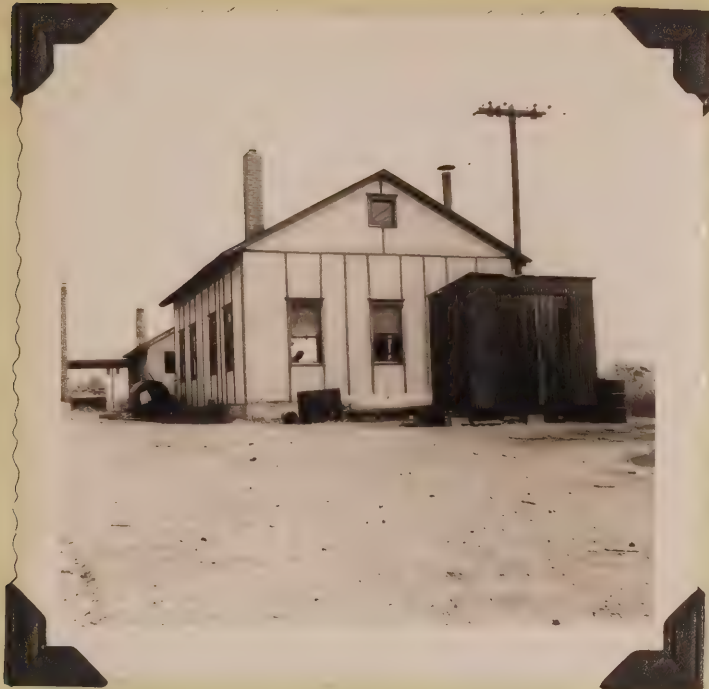
Rear View

<u>Fire</u>	Two 2½-gallon pump tanks, one 2½-gallon
<u>Extinguishers</u>	Foam; one sand pail.

<u>Electrical</u>	Replace taped-spliced extension cord to
	radio and electric clock located in
	locker with new cord.

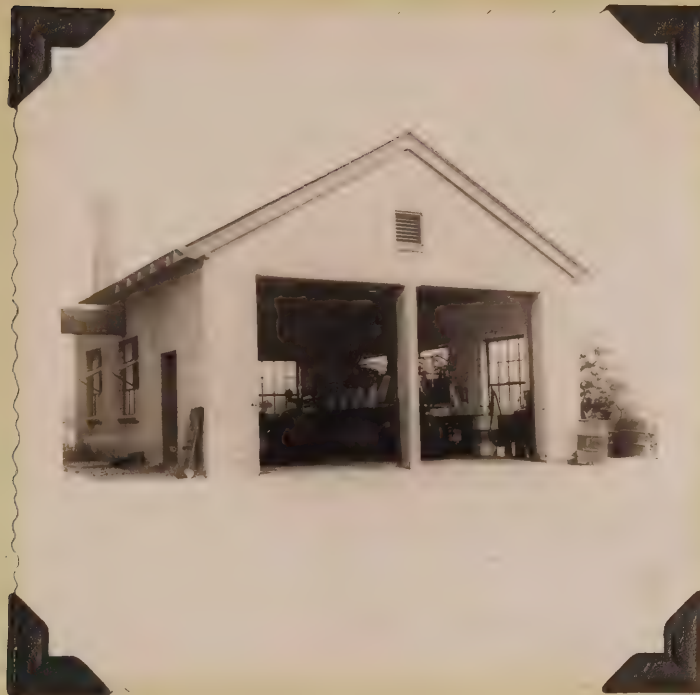
Grease House - Building #25

Construction Walls: 12" bricks, painted. Floor: cement-surfaced concrete. Grease Pits: concrete. Roof: slate on 1" x 8" matched roofers on 5" x 10" rafters 16" o.c. open finish. Windows: plain glass in steel sash. Doors: wooden, overhead type.

<u>Electrical</u>	Replace 20 and 30-ampere fuses with fuses of not over 15-ampere capacity.
-------------------	--

<u>Boilers</u>	Remove boiler and heat building from system in Building #1, or provide properly cut off boiler room adjoining present building. If it is impractical to carry out either of these suggestions, remove wooden bench (now located within 6 inches of boiler) at least 2 feet away from same.
----------------	--

<u>Extinguishers</u>	Remove accumulation of refuse from sand filled fire pail.
----------------------	--

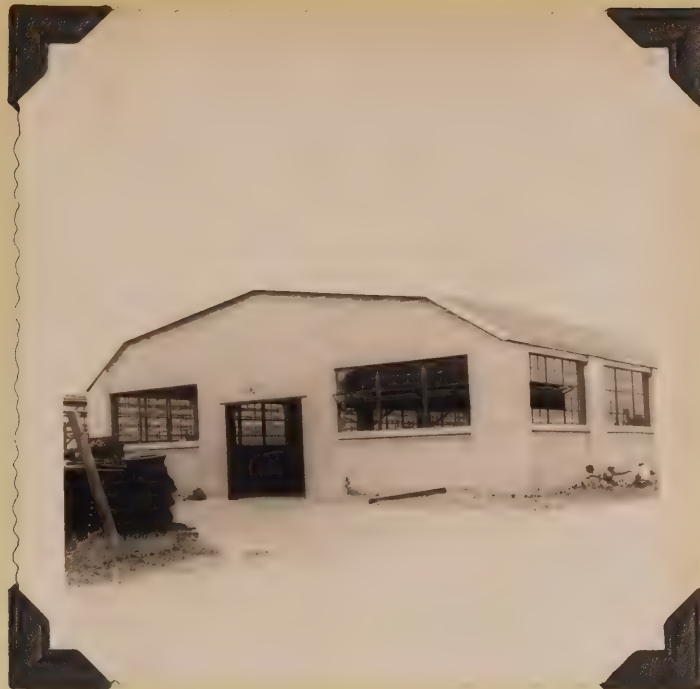
Sign Shop Building #27

Construction one story, cement block. Plant on steel truss roof, composition covered. Concrete floor and foundations. Cement block interior partitions.

Occupancy Storage of trucks and equipment. Traffic sign construction and repairing including woodworking, painting, sand-blasting, etc.

- Provide metal covers for metal trash barrels.
- Discard combustible rubbish containers.
- Clean out exhaust duct of paint spray booth.
- Remove paint from fusible link of boiler room fire door.
- Tighten-up swaying electric lamp drop where conduit is supported at ceiling level, main room.
- Provide automatic sprinklers in paint spray booth and room.

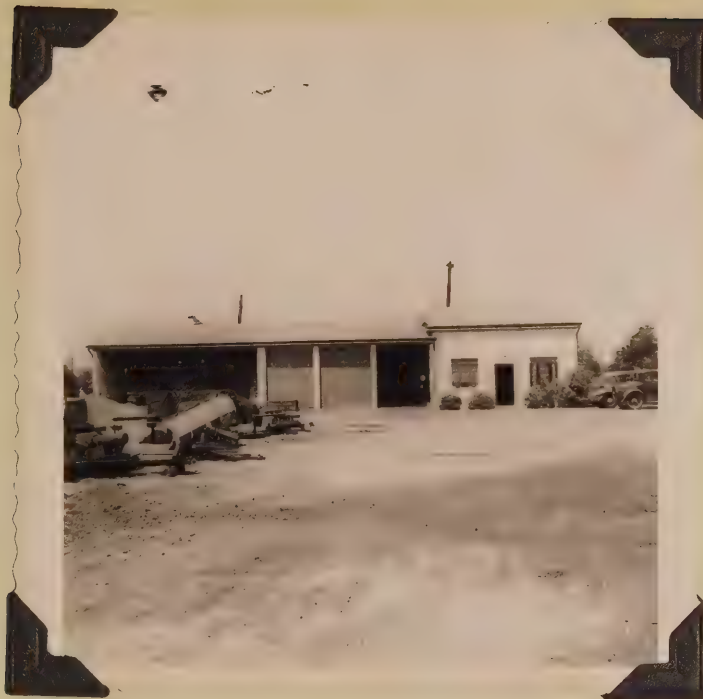
Woodbridge, N. J. Storage Building

<u>Construction</u>	<u>Height:</u> One story with loft over end section. <u>Walls:</u> cement block. <u>Roof:</u> asbestos shingles on 2" x 8" rafters 16" o.c. open finish inside. <u>Floor:</u> concrete, except 1½" board floor in loft.
<u>Mechanicals</u>	Electric lights. Wiring in conduit. Stove heat safely arranged. Ordinary toilet facilities.
<u>Occupancy</u>	Office, gasoline service station and miscellaneous storage of crushed stone, coal, and oil drums in open section. Storage of tractor, tools and miscellaneous supplies.
<u>Values</u> (as of 1/1/49)	Building - \$8,500. Contents - 204.11 Total \$8,704.11

Replace non-standard 5-gallon gasoline can with standard safety can bearing label of approval of the Underwriters' Laboratories, Inc.

Provide one 2½-gallon foam extinguisher bearing Underwriters' Laboratories label. If building is not constantly heated during winter months, substitute a 4-pound CO₂ extinguisher in lieu thereof.

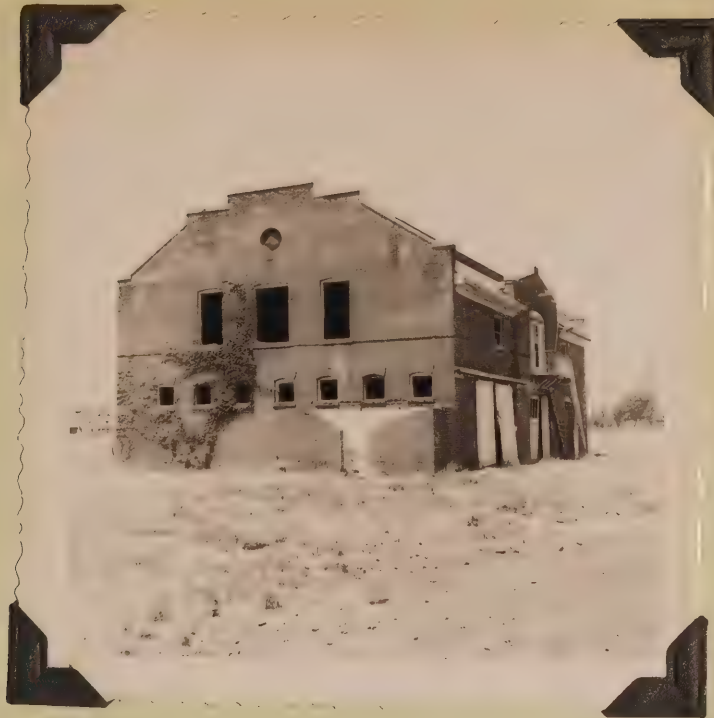
Elizabeth, N. J. Storage Building
(Route #25)

<u>Condition of Building</u>	Structurally sound walls, floors and roof. Vandals have done considerable damage to windows, roof gutters, exterior doors, etc. Clean second floor. Some combustible rubbish on first floor. (Same should be removed.)
<u>Fire Extinguishers</u>	None.
<u>Public Protection</u>	Fire hydrant 400 feet distant. About 1½ miles to fire station.

If building is not to be used in the near future, it should be securely boarded up to prevent further damage by vandals. If building is to be repaired and again used, we suggest the following:

1. Replace entire electrical wiring system with new equipment.
2. Provide safe means for heating building.
3. Provide proper type portable fire extinguishers depending on occupancy of the building.
